After a crippling fire destroyed a business unit at Coedcae Industrial Estate, Garland UK were appointed as key technical specialists for the challenging waterproofing refurbishment.

Project  
**Coedcae Industrial Estate**

Garland System  
**R-MER CLAD  
StressPly**

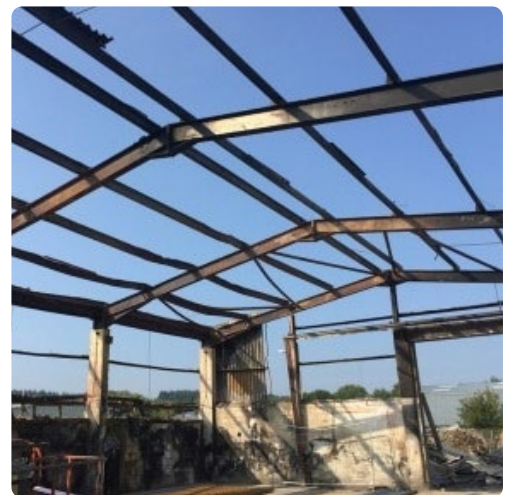
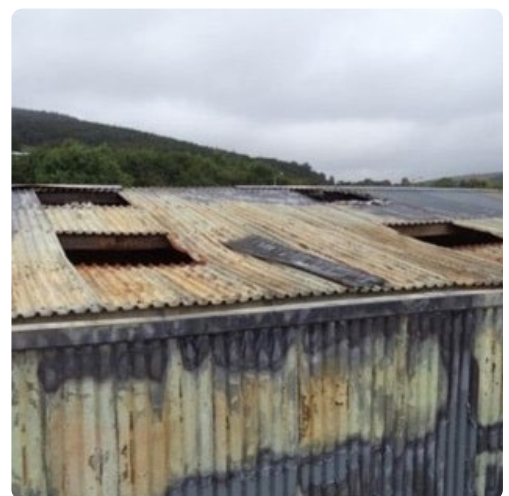
Dale conducted a thorough condition survey and supplied a detailed written report to the client, highlighting the severity of the building damage and the poor condition of the existing roof sections and walls. Approximately 2,000 sqm were either damaged beyond repair or had fallen into a state of disrepair, meaning that a full refurbishment of all roof and wall sections was required before the optimum waterproofing system could be implemented.

Before any works could commence, the immediate challenge was the efficient handling of the damaged roof and wall sections, which had to be completely stripped back and removed safely, leaving behind the original steel frame structure. With many of the structural steel supports and purlins suffering from severe damage in the fire, they had to be replaced before work could commence.

*Building damage and poor condition of the existing roof sections and walls*

Once all the existing roofing and cladding had been removed, work commenced on installing the new steel supports ready for the new metal R-MER CLAD system. R-MER CLAD is a profiled metal roofing and cladding system, that is both lightweight and fast to install, available in a wide range of durable, waterproof finishes. New gutters were also installed as part of the rebuild to ensure the system had the best rainwater management and was completely waterproof.

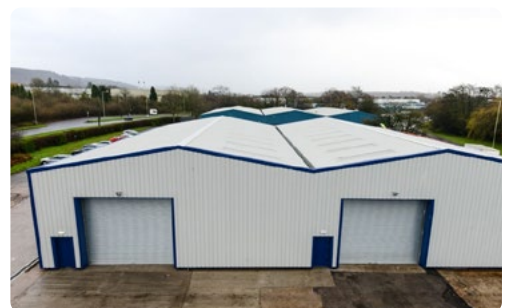
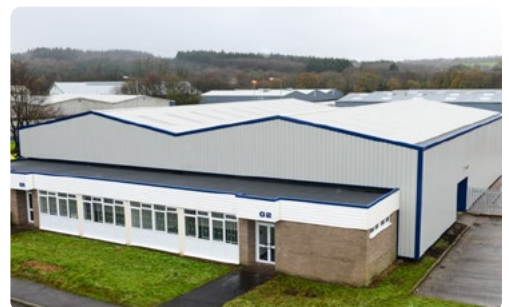
*Final R-MER CLAD and StressPly Flex installation*

On completion, Coedcae Industrial Estate had been completely transformed, turning the charred skeleton of the warehouse unit into a prominent and permanent building.
