Project  
**Pool Academy**

Garland System  
**StressPly Flex  
R-MER CLAD**

## Challenge

## Solution

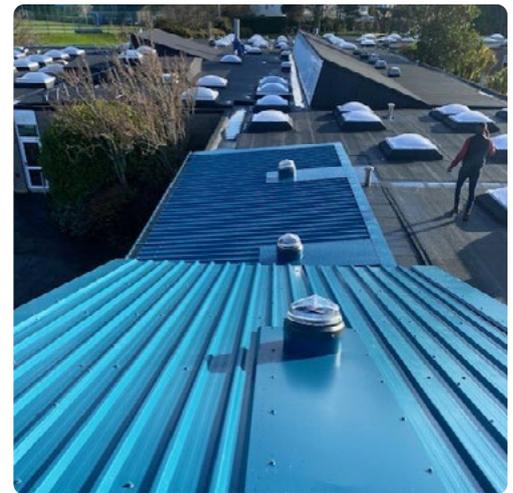
*Final StressPly Flex and R-MER CLAD installation*

A labour-intensive process was soon underway, to remove the mineral wool which had been mechanically fixed to the structure, before installing a full Garland **StressPly Flex** Warm Roof system. The system is built up from a newly installed Vapour Control Layer. To this layer, a fully tapered insulation scheme was installed to achieve 0.18w/m<sup>2</sup>k, the current building regulation requirement, and also to move water off the roof and to the outlet points in a more efficient way. On top of the insulation, a full torch-on system including a vented base sheet and mineral embedded cap sheet was installed.

The roof also had some falling metal roof sections which were suffering from cut edge corrosion and ingress around the fixing points where the perished seals were allowing water directly into the system. This was overlaid using a bar and bracket system and additional insulation, to again achieve 0.18 w/m<sup>2</sup>k, with Garland's **R-MER CLAD** system with the new roof being matched to the school's original colour scheme.

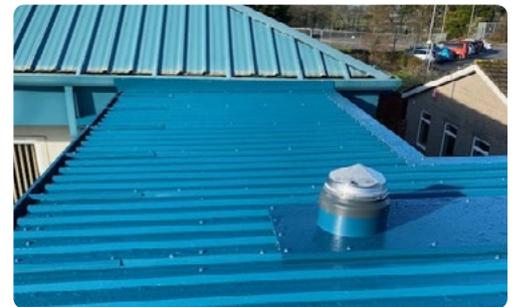
*Final StressPly Flex and R-MER CLAD installation*
