The failing metal tile roof had led to rotten timber battens and leaked moisture throughout the system at Tweeddale Primary. Garland's R-MER TILE ST system was specified in this fast turn-around job, completing in just 10 days.

Project
Tweeddale Primary

Garland System
R-MER TILE ST

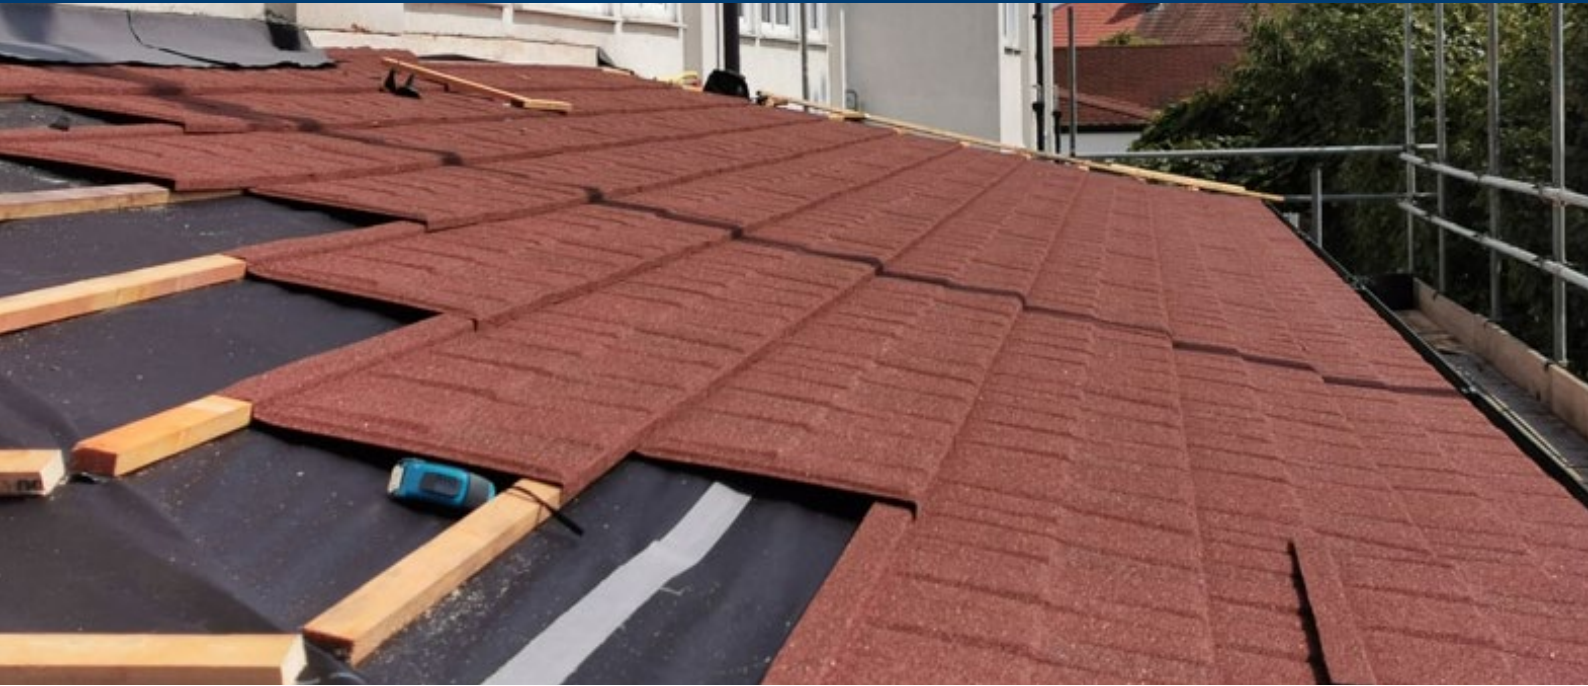
The existing metal tiles had failed significantly, allowing moisture to enter into the roof system. Over time, this had caused the timber battens to rot which led to several of the tiles becoming dislodged, splintered and severely weakened.

The original roof had inadequate falls along the eaves where the falls were far too shallow, causing poor drainage to the existing failed system and areas of ponding water.

Given the extent of the damage discovered in the essential technical survey and roof condition report investigations, there was one clear solution for Jack to propose to the client, a complete strip of the existing system was the best course of action to take.

Working closely with the building surveyor, Jack proposed a specification using the **R-MER TILE ST** system that combines the classic aesthetics of a traditional tile, with the high-performance characteristics of steel. An ideal waterproofing solution for the school, the original tile aesthetic could be retained and would require very little maintenance and protect the school for decades to come.

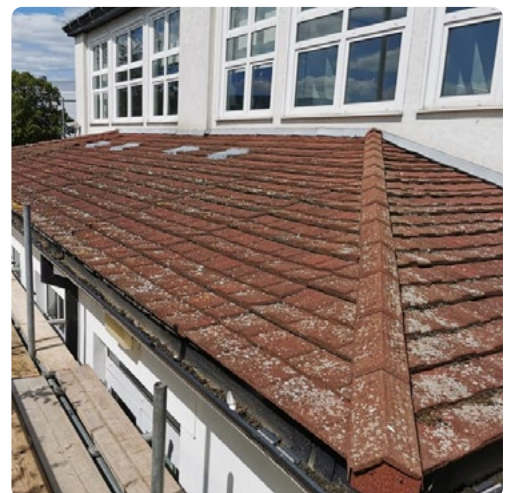
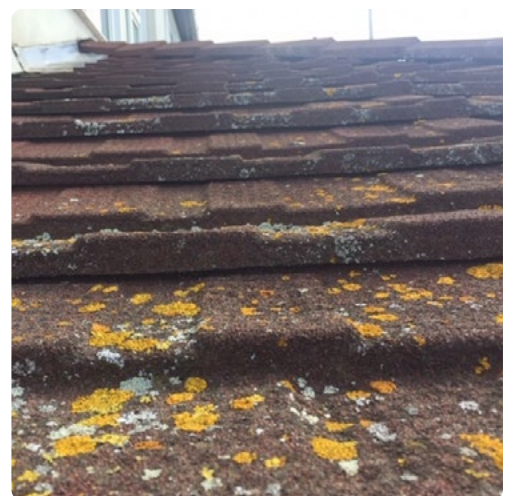
Pitched sections were beginning to display significant failures

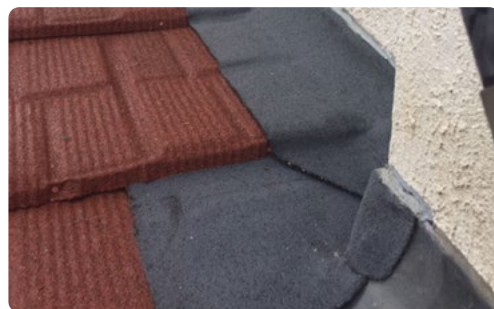
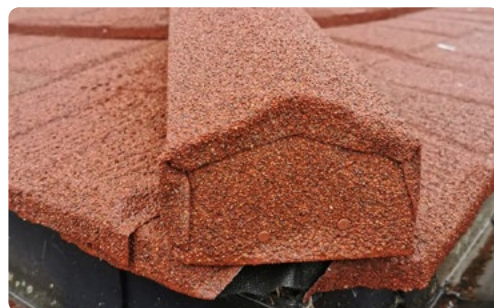
Final R-MER TILE ST installation

Overall the team working on the project were extremely impressed by the simplicity of the installation process, where the R-MER TILE ST was installed in just 5 days and the project was completed in 10. The school was delighted with the speed at which Garland was able to complete the project, meaning students could continue their classes with minimal disruption incurred.
