Haslemere Rugby Club were looking for a long-term waterproofing system that would also incorporate their environmental targets, to improve thermal efficiency and generate their own supply of renewable energy.

Project
Haslemere Rugby Club

Garland System
R-MER CLAD
Solarise PV System

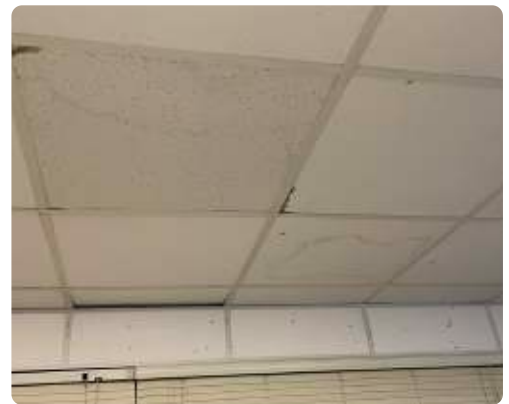
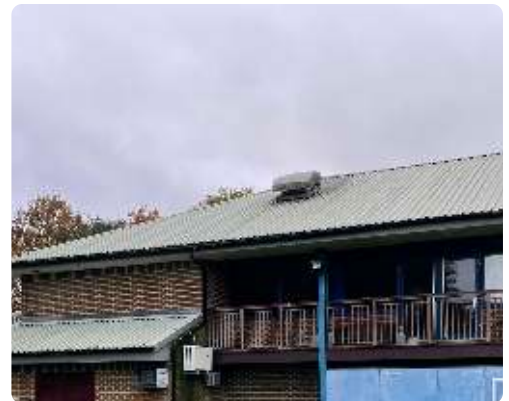
Water ingress was apparent throughout the building. Additionally, due to poorly performing insulation the building was proving costly to keep warm during the cold winter months.

Daniel specified Garland's R-MER CLAD metal roof system, a lightweight and hardy trapezoidal roofing and wall system that would perfectly suit the Club's requirements. R-MER CLAD is made from recycled materials and is 100% recyclable when it comes to the end of its natural life, making it the ideal choice to reduce the building's overall embodied carbon.

Utilising R-MER CLAD to encapsulate the existing roof structure ensured minimal disruption to the Club's daily activities, mitigating unnecessary landfill waste and providing a twin-skin insulated build-up to improve the building's overall thermal efficiency.

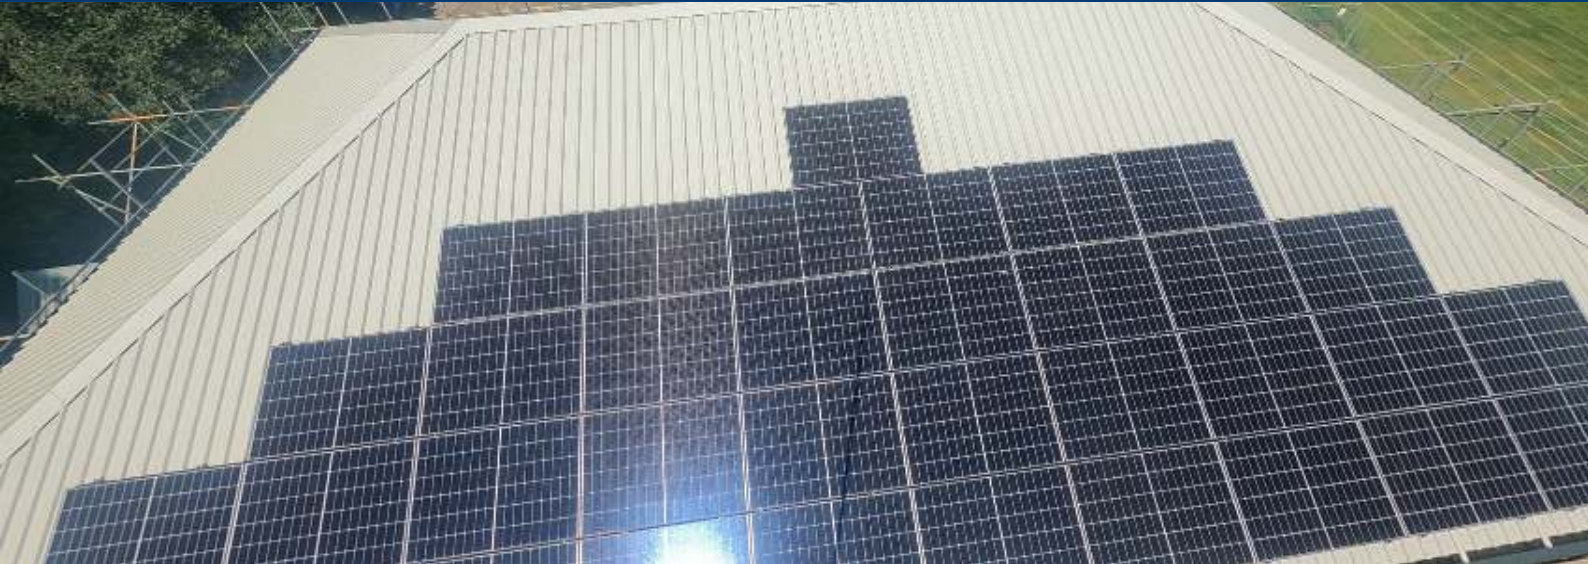
Garland UK Approved Contractor, Gable Roofing, set to work on the installation incorporating a new Vapour Control Layer (VCL), followed by a galvanised steel Garland Bar & Bracket system with a bracket height of 260mm. Mineral insulation was then added to bring the roof system up to current Building Regulations, followed by Garland's R-MER CLAD 0.7 gauge plastisol coated steel sheets. For the final details, R-MER Fix Stainless Steel Fixings with colour-matched caps and appropriate washer sizes and colour-matched Flashings were installed.

To avoid any penetrations in the new R-MER CLAD sheet being made to fix the Solarise system, Daniel specified that a custom bracket system was affixed directly onto the crowns of the R-MER CLAD roof sheet, alongside EPDM washers to ensure that the roof's waterproofing function was not compromised.

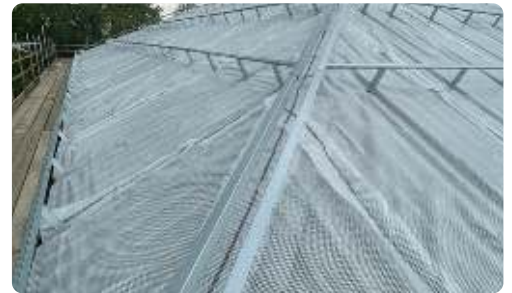
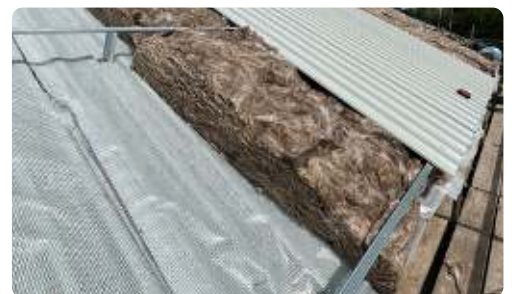
Twin skin R-MER CLAD installation allowing for insulation within the void.
