Garland UK's R-MER SEAM roof replacement enhances safety and efficiency at Ysgol Llwyn Yr Eos in Aberystwyth, as the perfect match for a challenging copper roof replacement.

Project
Ysgol Llwyn Yr Eos

Garland System
R-MER SEAM

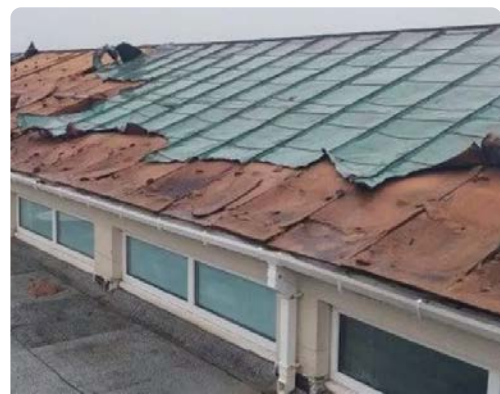
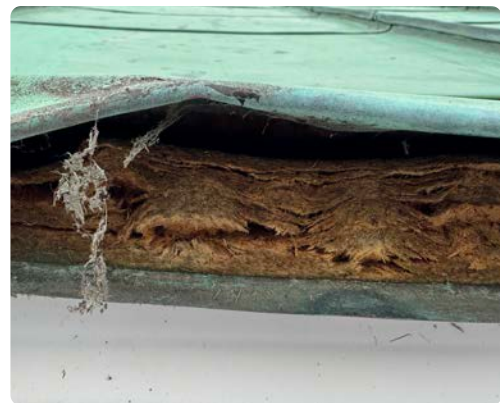
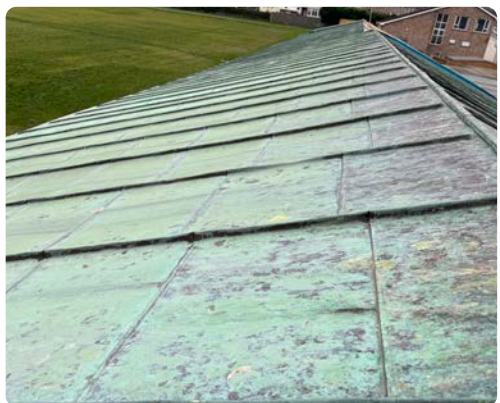
The roof was in a critical state. Due to vandalism, missing copper sheeting had left fibreboard insulation exposed and saturated with moisture. This compromised the roof's structural integrity, making it unstable and unsafe to access. The risk of collapse into classrooms created an immediate safety hazard.

Garland UK technical manager Jordan Thomas developed a targeted solution to address the roof's structural dangers and thermal inefficiencies, ensuring safety and long-term performance. Installed by approved contractor, The Complete Roofing Company, the project began with completely removing the damaged roofing materials. Stripping the existing layers down to the timber deck eliminated the moisture-saturated insulation and unstable components, creating a secure base for the new system.

A vapour control layer was installed to protect the roof from future moisture issues, ensuring the new insulation remained dry and durable over time. High-performance 130mm PIR insulation was added, significantly enhancing the building's thermal efficiency and addressing the issues of fluctuating indoor temperatures.

The final stage involved the application of the R-MER SEAM, a low-profile steel standing seam system with a secret fix. The lightweight system allowed for efficient installation, where the steel panels effortlessly clicked into place, delivering a seamless and highly durable finish. Its colour-matched steel coating and sleek appearance retained the aesthetic appeal of the original copper roof while offering superior security and long-term performance.

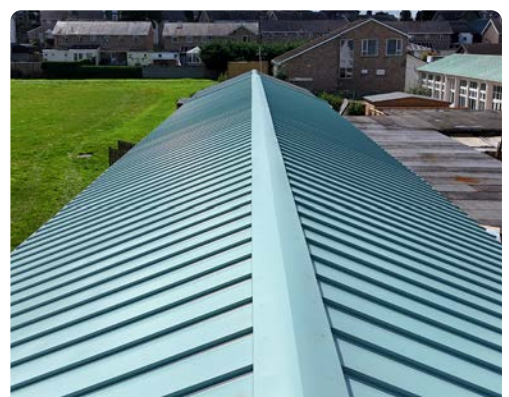
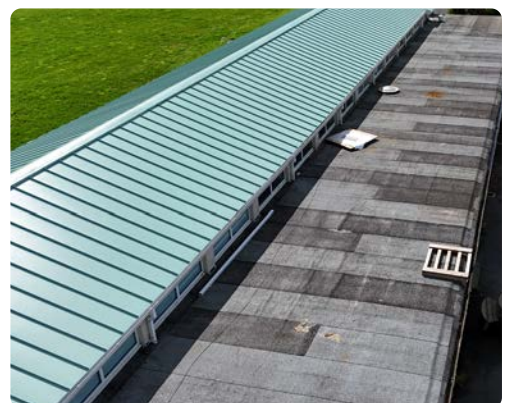
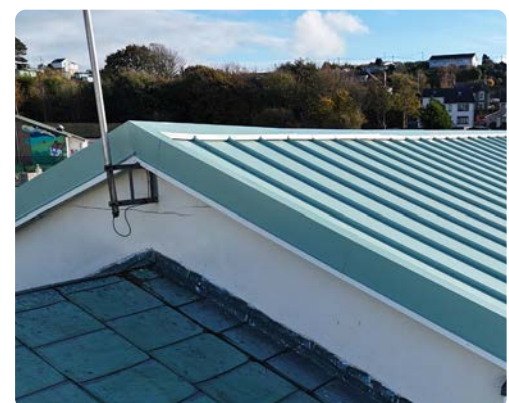
The roof replacement transformed Ysgol Llwyn Yr Eos into a safe, efficient, and visually appealing environment. The structurally fragile roof was replaced with a durable R-MER SEAM system, eliminating safety risks and restoring confidence in the building. Improved thermal performance to a 0.18 U-Value provided a stable indoor climate, reducing heating costs and enhancing comfort for students and staff year-round.
