Garland System  
**R-MER LOC**

Client  
**Denbighshire County Council**

Building resilience restored as popular leisure centre reopens after storm damage forced closure.

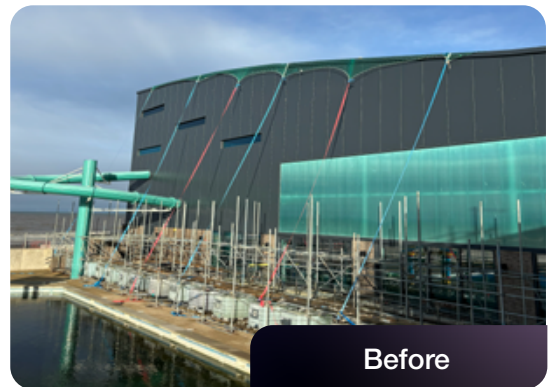
Before

The storm exposed critical weaknesses in the original roof design, which had failed to cope with the site's wind load demands. The closure meant immediate loss of revenue, reduced access to community leisure facilities, and growing urgency to reopen.

Garland UK Technical Manager Rob Wall specified the [R-MER LOC](#) standing seam metal system, designed for storm resilience, thermal efficiency, and long service life in marine climates. Its penetration-free, zip-free seam design enabled faster installation and allowed for thermal movement without panel distortion.

The system was tailored to the building's complex geometry, with 22 metre top sheet runs and 18 metre lower runs. Approved contractor, [Future Roof Leeds](#), carried out the works, reusing the existing perforated aluminium liner where possible to reduce waste and disruption.

A high-performance, foil-lined vapour control layer was installed, along with upgraded insulation and a breather membrane suitable for coastal exposure. Acoustic infills were also integrated to maintain internal sound control, enhancing the original system's acoustic performance.
