Tower Bridge - Ticket Offices

Garland System
Dura-Coat

A considerate roof refurbishment at Tower Bridge ticket offices, delivering waterproofing protection that preserves the heritage appearance and physical integrity of this iconic landmark.

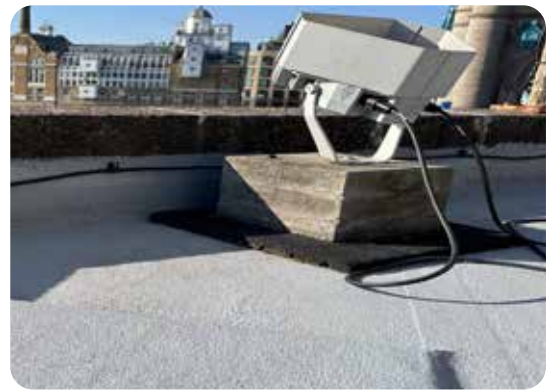
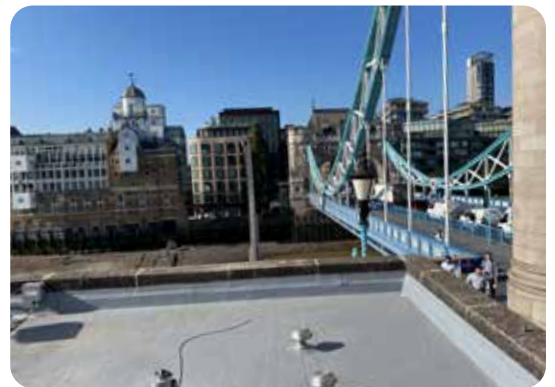
The system offered several critical advantages. Its flame-free, cold-applied application removed the need for hot works and eliminated associated risks within a live public setting. Dura-Coat's rapid curing properties ensured reliable installation even in lower temperatures, with catalyst levels adjusted daily to suit site conditions. Crucially, the system build-up allowed for direct application to the cleaned asphalt substrate without any alteration to existing thresholds or parapet levels.

“
Dura-Coat's flame-free, cold applied application removed the need for hot works.
”

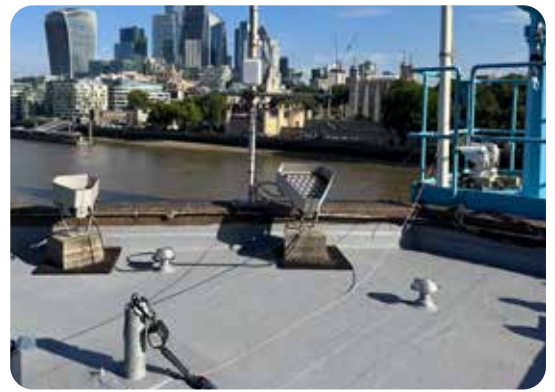
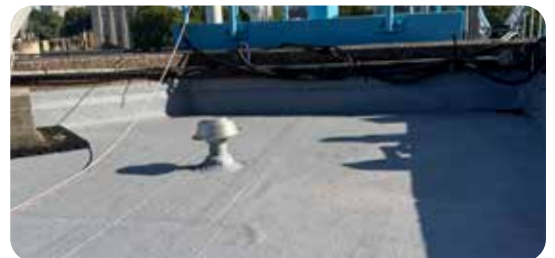
Thanks to the non-invasive specification, the works were completed without altering existing thresholds, avoiding the need for structural modification and maintaining compliance with strict conservation requirements. The finished result visually replicates the original light grey coating, ensuring continuity with the bridge's architectural character.

“
The refurbished roofs now provide high-performance waterproofing protection while **fully preserving the heritage appearance.**
”
